NASA Technical Memorandum 107325  
AIAA-96-4292

# Hypervelocity Impact Testing of Nickel Hydrogen Battery Cells

Prepared for the  
1996 Space Programs and Technologies Conference  
sponsored by the American Institute of Aeronautics and Astronautics  
Huntsville, Alabama, September 24-26, 1996

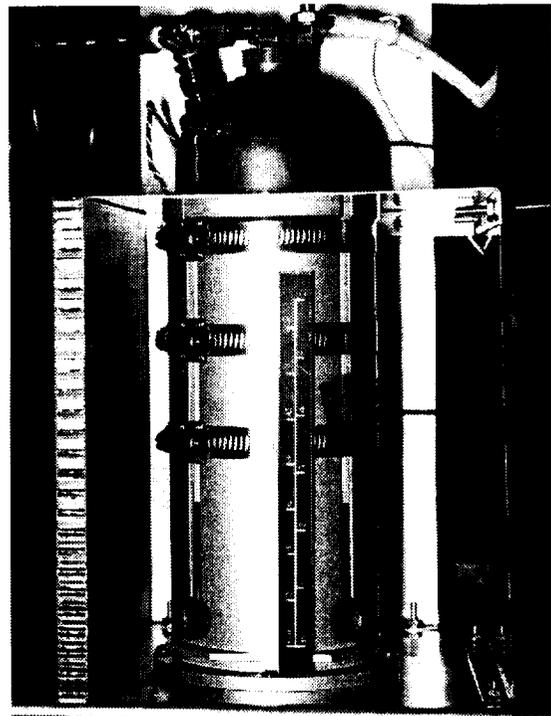
Figure 2.—Test configuration for Ni/H<sub>2</sub> cell side impact test. Particle approached the cell from the left impacting the honeycomb at a 90° angle.

For the actual cell side impact tests (1B, 2B, and 3B) a 9 by 9 in. piece of honeycomb was placed 0.9 in. from the side of the battery cell as shown in Fig. 2. The side impact shots were simulating a particle impact on the side of the honeycomb enclosure box which then impacted the battery cell. For the actual cell dome impact tests (1D and 2D) a 6 by 6 in. piece of honeycomb was placed 2.0 in. from the battery cell dome as shown in Fig. 3. This test simulated a particle impact on the top of the enclosure box which then impacted the cell dome. Due to the location of the fill tubes and valves on the cell terminals, we could not put the battery cell perpendicular to the honeycomb. It was positioned at a 45° angle. For all tests, the honeycomb face sheet was positioned perpendicular to the particle flight path. This was thought to be a worst case because the particle's path through the honeycomb is the shortest. For all the battery cell tests a 16 by 6 in. witness plate of 25 mil thick Inconel 718 was placed 2.0 in. behind the battery cell and 2.0 in. next to the battery cell parallel to it and at right angles to each other. There was also a piece of honeycomb 0.9 in. away from the cell in front of the side Inconel witness plate. The objective of these witness plates was to simulate a nearby battery cell and the enclosure box to determine if there was any secondary debris from the impact that could possibly damage other battery cells or escape from the enclosure box. All of the materials were weighed before and after the impact tests.

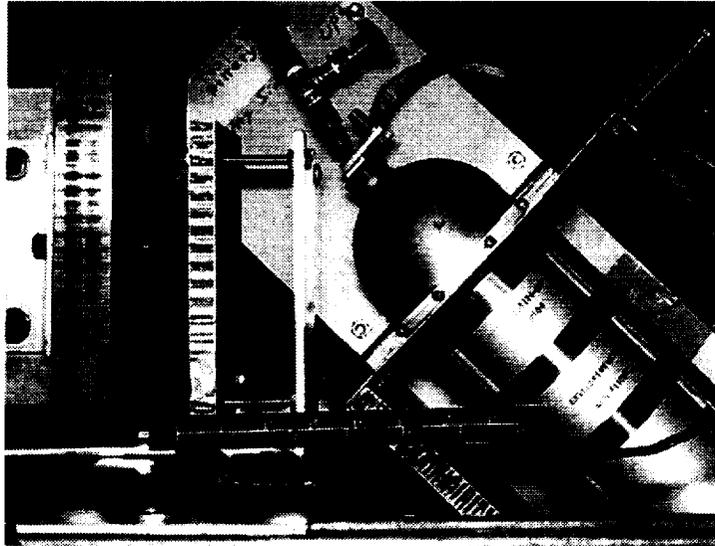
Figure 3.—Test configuration for Ni/H<sub>2</sub> cell dome impact test. Particle approached the cell from the left impacting the honeycomb at a 90° angle.

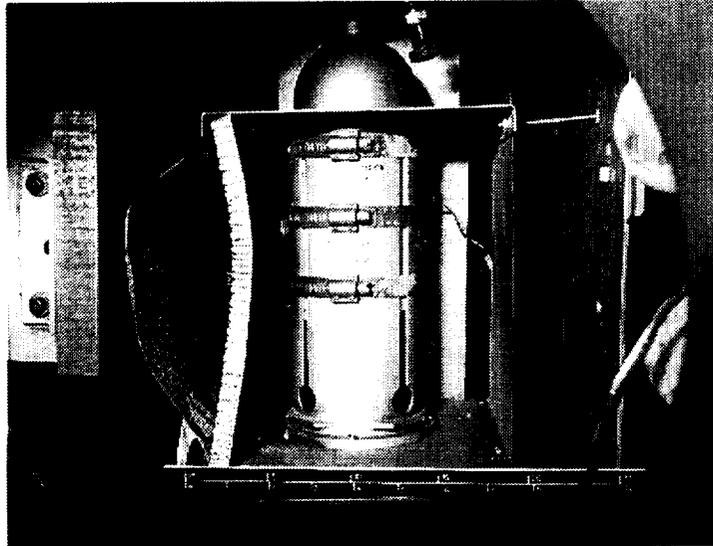
Figure 5.—Post-impact view of Ni/H<sub>2</sub> battery cell and honeycomb in Test 3B.

hole of 7.6 mm diameter. There was a tear 1.5 cm long and 4.6 mm wide 10.2 mm above the entrance hole indicating particles came back through the honeycomb and front face sheet. Figure 4 shows the inside of the delaminated front facesheet and the damage done to the interior honeycomb. The front face sheet was completely delaminated from the honeycomb which bowed toward the cell. This is shown in Fig. 5. The exit hole had a diameter of roughly 6.1 cm with 8 petals. Figure 6 shows the exit hole on the back side of the rear facesheet. There was liquid KOH on the cell side of the honeycomb.

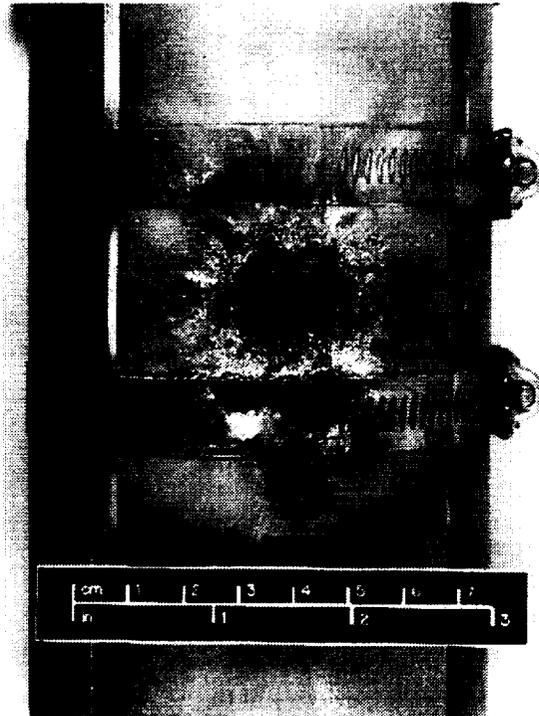
Figure 7.—Close-up of impact area on Ni/H<sub>2</sub> cell aluminum thermal sleeve after Test 3B.

The aluminum sleeve had a heart-shaped hole of roughly 2.0 cm in diameter with several other impacts within a radius of 2.0 cm. There was also KOH residue and black residue on the aluminum sleeve. A close-up of the impact area is shown in Fig. 7. The cell pressure vessel had a 10.2 mm diameter hole with 4 cracks between 10.2 and 17.8 mm in length emanating from it. The impact area on the bare cell after removal of the thermal sleeve can be seen in Fig. 8.

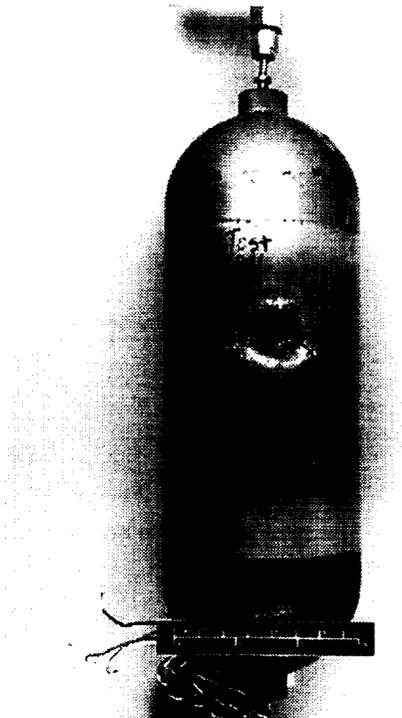
Figure 8.—Ni/H<sub>2</sub> battery cell without thermal sleeve after a 6 km/sec impact in Test 3B.

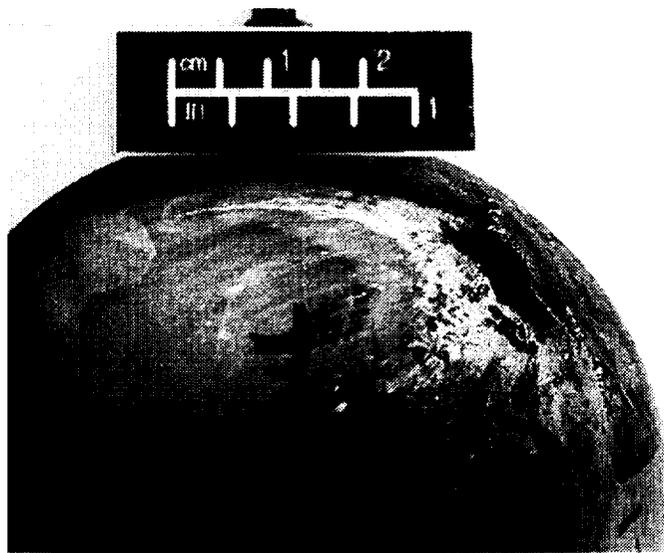
Figure 9.—Ni/H<sub>2</sub> battery dome from Test 1D after a 7 km/sec impact to the dome area.

In this test a 4.8 mm diameter projectile traveling at 6.72 km/sec penetrated the battery cell dome with a series of small holes, which appeared to cause a crescent-shaped rupture 3.0 cm long formed by several holes. The ruptured section lifted 3.8 mm above the surface of the dome as a result of the cell venting. The dome impact area is shown in Fig. 9.

There was also KOH on the battery cell dome and thermal sleeve. On the dome, besides the rupture, there were about a dozen small holes and some metal spattering around the impact area. The honeycomb and Inconel

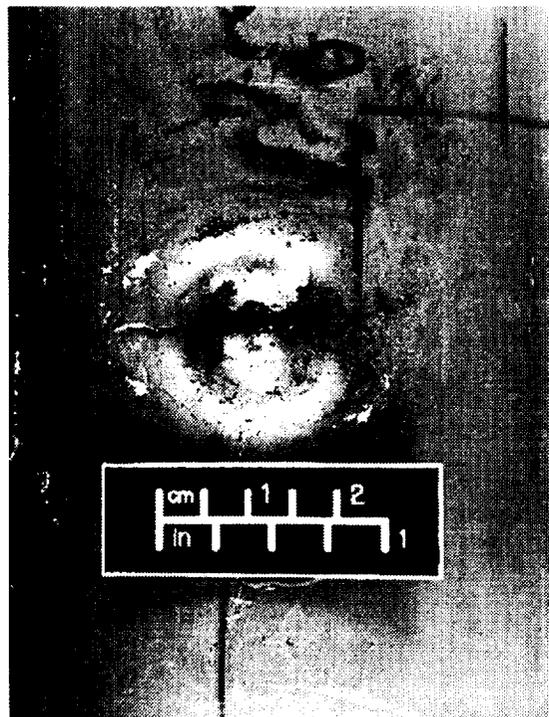
Figure 10.—Close-up of Ni/H<sub>2</sub> battery pressure vessel (without thermal sleeve) from Test 2B after a 3 km/sec impact.

The impact made a dent and a fissure-like penetration into the pressure vessel. The main crack was 1.8 cm long with 1.0 and 0.8 cm long secondary cracks. At its widest point the main crack was 2.5 mm wide. A close-up of the cell penetration is shown in Fig. 10.

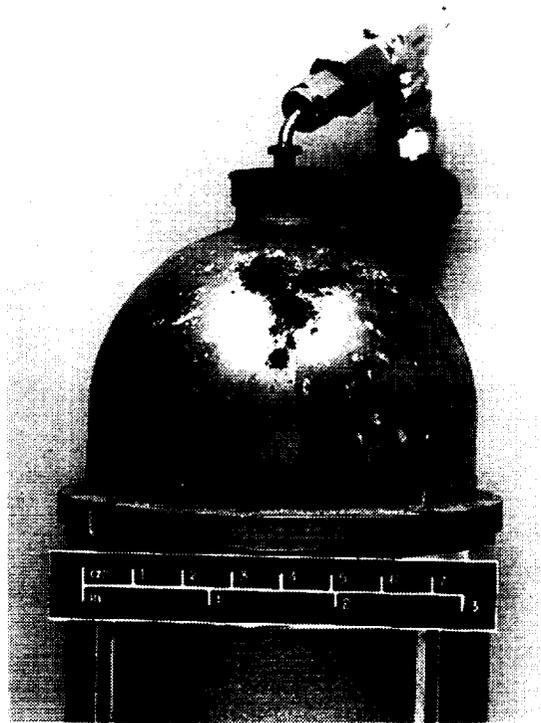
Figure 11.—Ni/H<sub>2</sub> battery cell from Test 2D after a 3 km/sec impact to the dome area.

The pressure vessel dome was penetrated in three places. Two holes approximately equal in size were closely spaced and about 5.1 mm in diameter. A third hole about 12.7 mm from the other two was 2.5 mm in diameter. White residue, presumably KOH, was splattered around the holes and it also dripped down the side of the cell. The dome impact area can be seen in Fig. 11.
